Radon Mitigation in Schools: Case Studies of Radon Mitigation Systems Installed by EPA in Four Maryland Schools are Presented

Radon mitigation in schools

Case studies of radon mitigation systems installed by EPA in four Maryland schools are presented

By David Saum, A.B. Craig and Kelly Leovic

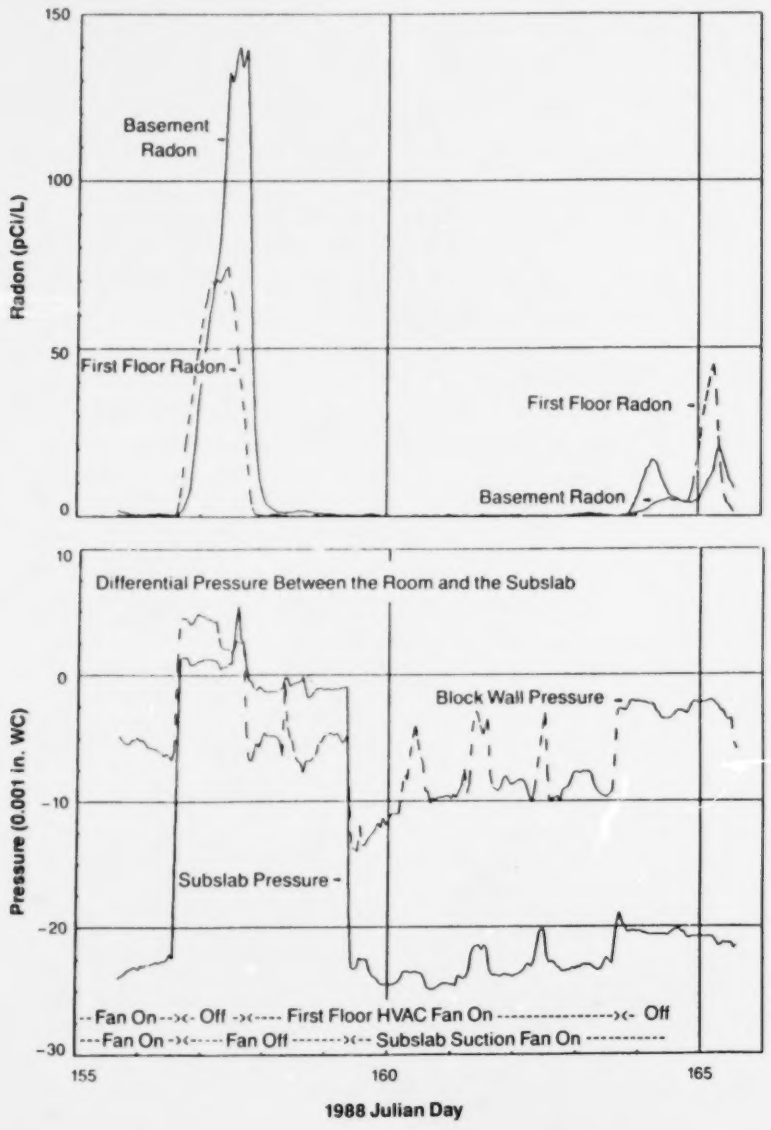
Figure 2. Radon and pressure measurements over a 10-day period in Case Study B.

Over the weekend (day 156), the HVAC system and the single-point subslab suction system on the first floor were turned off, and the radon levels rose quickly to more than 70 pCi/L on the first floor and 140 pCi/L in the basement.

On day 157, the subslab suction system remained off, but the first-floor HVAC system was turned on. Radon levels on both floors dropped and the differential pressure under the slab and within the block wall became slightly negative relative to the room. On days 158-163, both the HVAC system and subslab suction system were operating and radon levels remained low.

On days 164 and 165, the subslab suction system was operated and the first-floor HVAC system was off. This increased first-floor radon levels to 40 pCi/L, indicating that one suction point was not adequate if the HVAC system was not operating.

To ensure acceptable radon levels on the first floor while the HVAC system was not in operation, another suction point with a 3-ft-diameter suction pit was installed on the first floor. Addition of this suction point reduced levels on the first floor, although radon levels on both floors still rose above 10 pCi/L at night with the HVAC system off.
